Deckhand killed when struck by collapsed boom

FACE 99-AK-020

Release Date: August 28, 2000

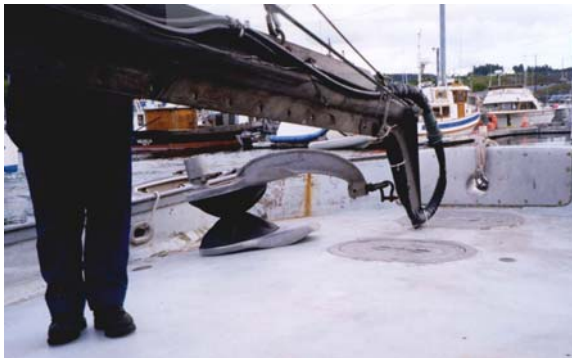
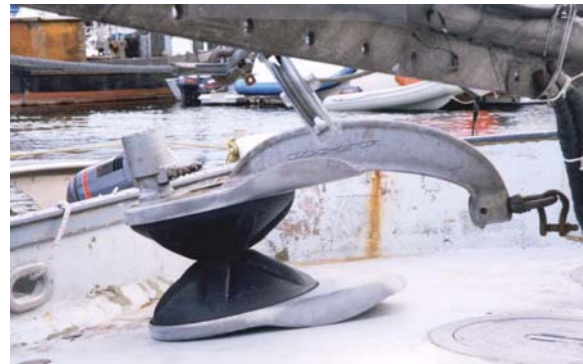
A power block was used to pull the net back on board the vessel. The block was hydraulically powered with a V-shaped sheave lined with rubber (Figure 4a and 4b). The power block hung from the boom above the aft part of the vessel. As the power block brought the net on board, one or two deckhands stood under the boom to pull down on the net (to help it through the block) and
